Weather Barriers for Residential Construction

VYCOR® enV™ provided an energy efficient weather barrier to protect against irreparable moisture damage.

Project	Rockwood Lodge, Highland, North Carolina
General Contractor	John Wesley Hammer Construction Inc., Decatur, Georgia
Architect	Tab Associates, Edwards, Colorado
GCP Solution	VYCOR® enV™

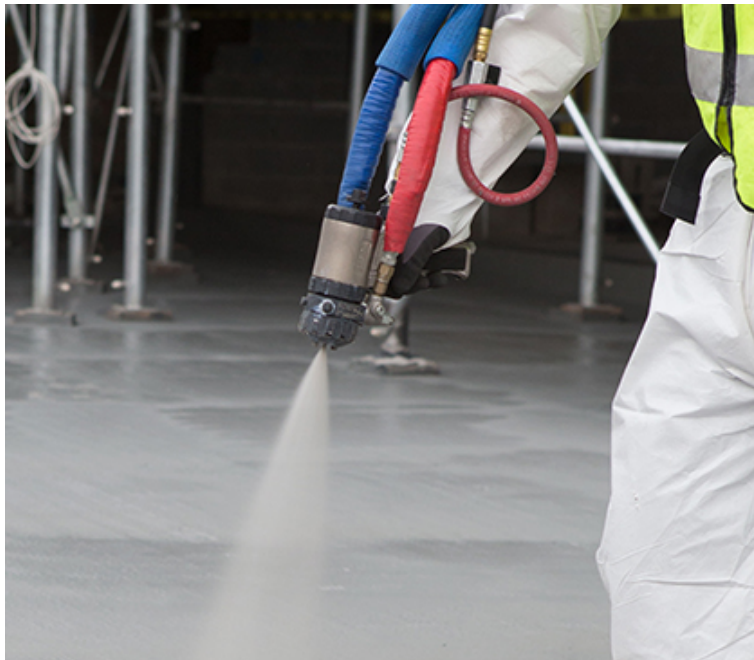
In the end, Tab associates needed to essentially dismantle the house before putting it back together. The Poplar bark shingles, original house wrap, and old OSB sheathing were removed, and the windows and doors were pulled out. Lastly, the home was re-insulated where voids were found, and it was re-sheathed with higher-grade AC plywood sheathing. Only then was VYCOR[®]enV[™] applied.

VYCOR[®]enV[™] was then sprayed and rolled from the underside of the archways down to the foundation, forming a continuous barrier that was bound with joint tape at the seams. The system allowed water vapour to escape from the inside, but repelled liquid water from the outside, ensuring that it remained dry and free of mould.
