ELIMINATOR[®] overcomes tough environmental challenges

Waterproofing Warsaw's busiest expressway

Project	Grota Bridge
Client	General Directorate of Roads and Motorways
Contractor	B7
Authorised Contractor	DWD Service SP.Z.O.O
(Waterproofing Applicato	
GCP Solutions	ELIMINATOR [®] Bridge Deck Waterproofing system

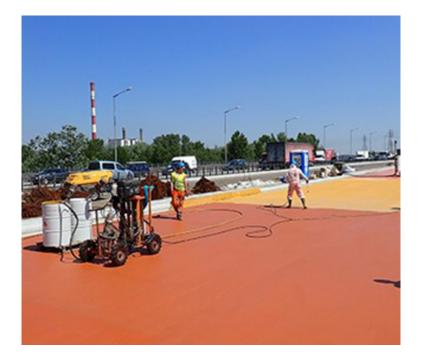
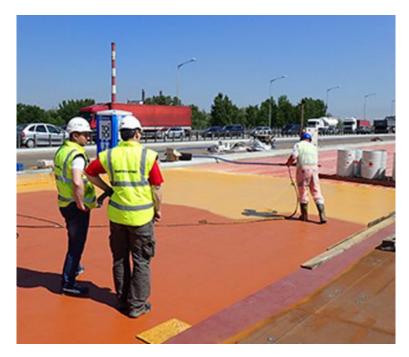
Once the Grota's deck was exposed, the project team discovered that it had many irregularities, including protrusions from the steel mesh that could not be removed. The result was that it had an uneven surface profile.

B7 and ZBM Inwestor Zastępczy Sp. Z o.o. selected the ELIMINATOR[®] system from Stirling Lloyd (now GCP Applied Technologies). DWD Service Sp. z o.o. prepared the deck by shot blasting using metallic grit, an independent assessment was completed to ensure the correct deck preparation to achieve a strong bond between the substrate and subsequent waterproofing.

The waterproofing system comprised of an initial anti-corrosive primer, ZED S94, which served to protect the newly exposed steel deck and enhance the bond between the deck and membrane. Once this dried, the ELIMINATOR [®]system was spray applied in two coats of contrasting colours to aid in quality control.

Tack Coat No. 2 was then applied to the membrane, an adhesive that helps to enhance and ensure a strong bond between the membrane and the surfacing. The adhesion between the deck, the ELIMINATOR[®] system and surfacing was crucial for extending the life of both the surfacing and the structure.

Due to the fast curing and the ease of application of the ELIMINATOR[®]system, DWD were able to apply 1000m² of the full bridge deck waterproofing system per day.
